A MOGAS power walkdown identifies valve leakage issues and their severity. Our report provides data so you can prioritize critical issues immediately, while budgeting and scheduling potential problems for a more appropriate time.

Severe service valves, and the equipment they protect, represent significant capital investments in your plant. To protect those investments and the improve performance of your facility, we offer the MOGAS power walkdown — an inspection of your critical valves using contemporary technology and technical experience.

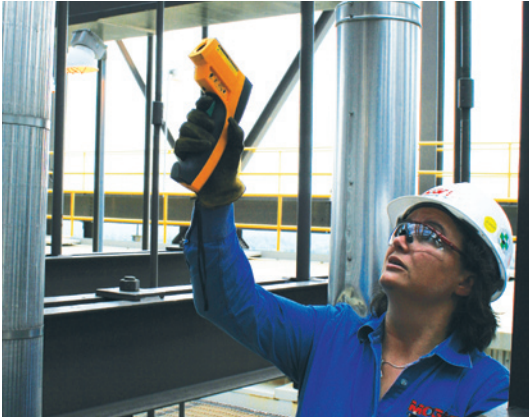
With consent, a small incision may need to be made through the insulation to record a temperature. We will consider every non-invasive method prior to cutting any insulation. In instances where there is no direct valve access, openings around the stem or downstream in the pipe run will be used.
